Ham Radio 101
The Anatomy of a Restoration
Part 2

For this article, I will be concentrating on an HW22A Heathkit single band transceiver. It covers the 40M band from 7.2MHz to 7.3MHz. This was the phone band when it was originally designed.

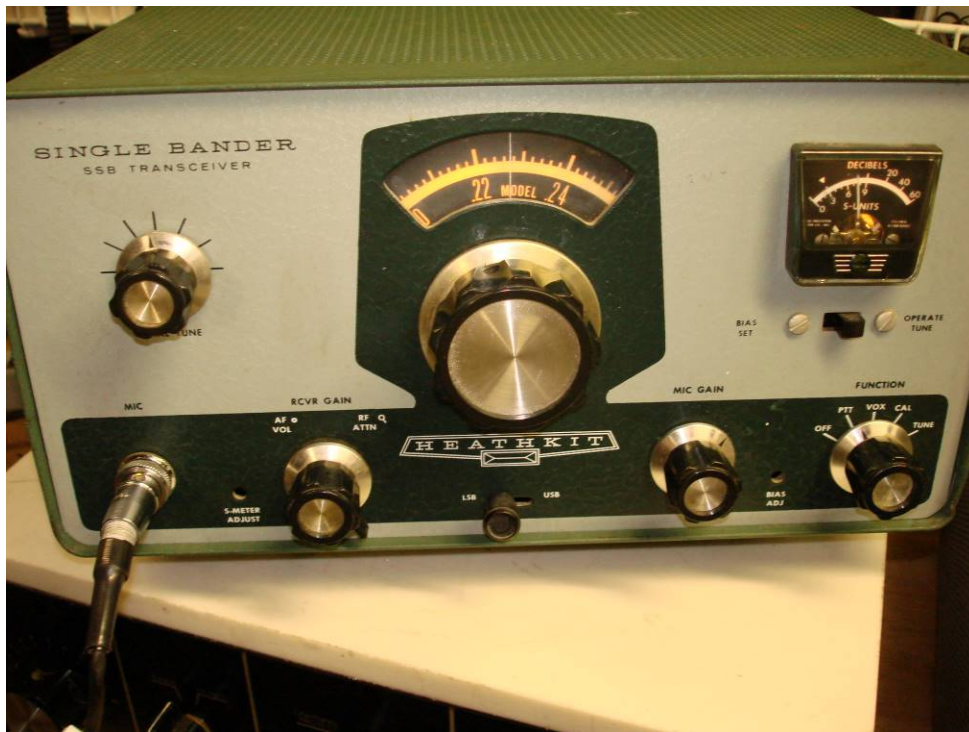
Figure 1
Front of the HW22A

This version covered Upper Sideband and Lower Sideband, even though most of the activity was on Lower Sideband (LSB)

Editor's note: The picture in figure 1 is not the rig being restored. It is used only for a sample of an HW22A.

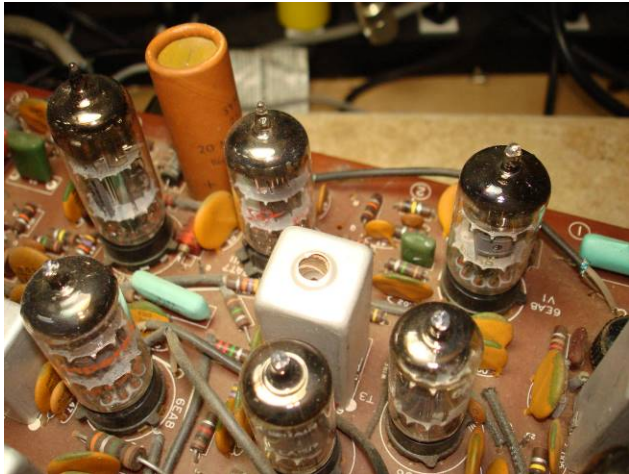
Figure 2
Original Cap

However, an electrolytic capacitor started to fall out of the chassis. The capacitor is shown in figure 2. It looks like round cylinder about .75 inches in diameter and about 2 to 3 inches tall.

There were two avenues of repair. The easiest one is to just re-solder the existing capacitor. However, since the radio is 50 years old, I decided to replace the capacitor.

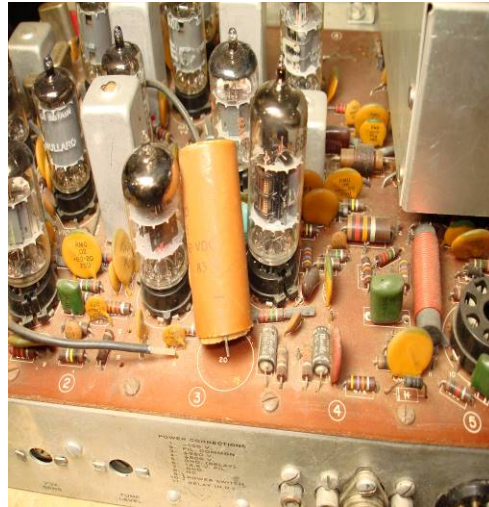
Figure 3
Unsoldered Cap

Figure 3 shows the capacitor lifted from the circuit board. It is a 20 ufd, 400Vdc capacitor and it is part of the audio circuit.

The old cap measured 24 ufd shown in figure 3. The new cap measures 22Ufd and is rated at 450 volts DC.
