Ham Radio 101
The Anatomy of a Restoration
Part 1

For this article, I will be concentrating on an HW22A Heathkit single band transceiver. It covers the 40M band from 7.2MHz to 7.3MHz. This was the phone band when it was originally designed.

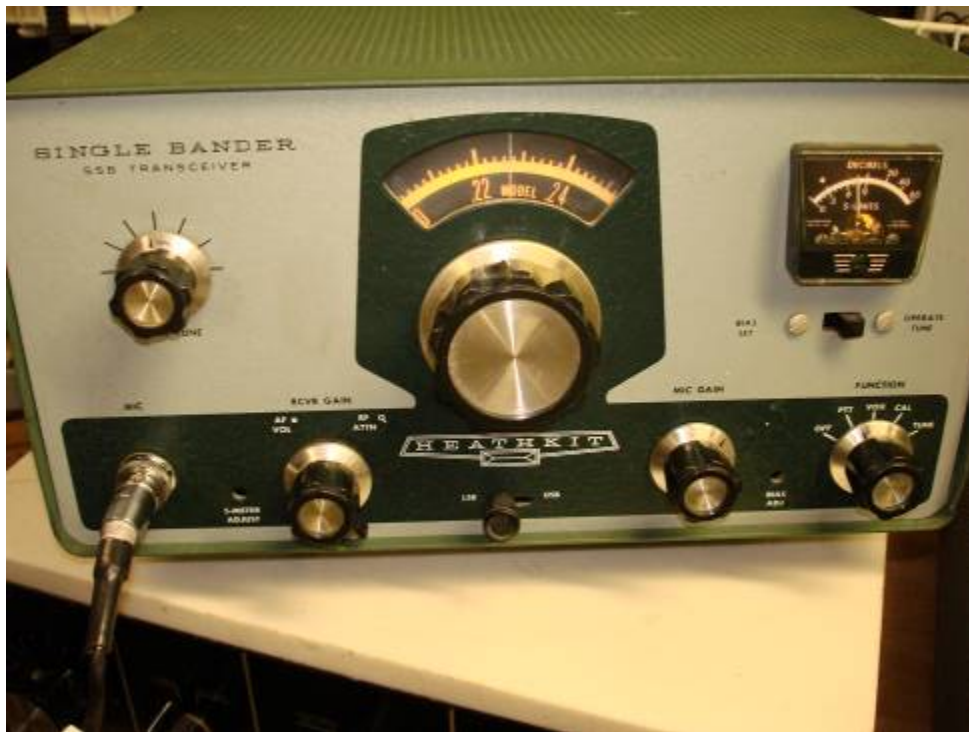
Figure 1
Front of the HW22A

Editor's note: The picture in figure 1 is not the rig being restored. It is used only for a sample of an HW22A.

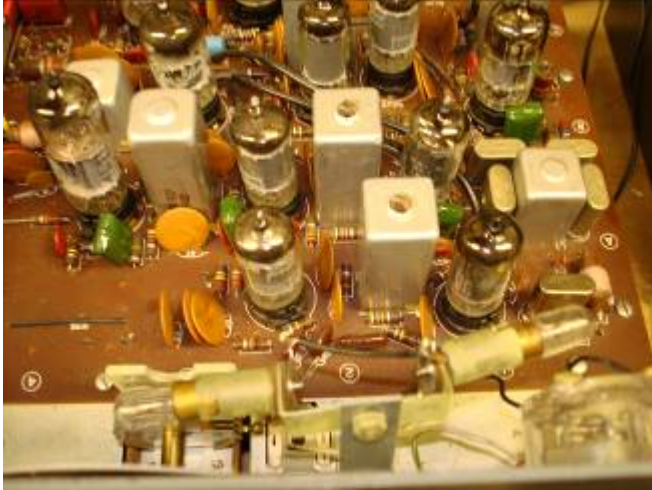
Figure 2

In figure 2, you can see three green color capacitors. These are .1ufd cathode bypass capacitors.

Upon an initial inspection, I found one of the capacitors completely open.

With an open capacitor, the gain defaults back to the cathode resistor.

Picture of Cathode Bypass Capacitors

positive response of the receiver. These capacitors are 50 years old and the values have changed from the nominal .1ufd to an open circuit.

I replaced all of the bypass capacitors. This added to the

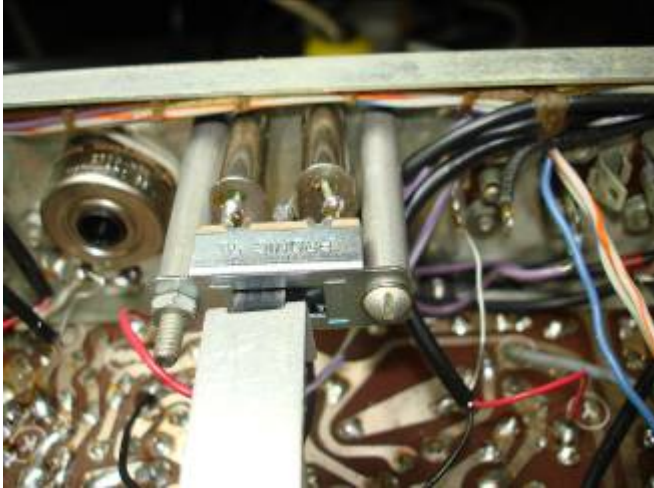
Figure 3

I found that the crystal oscillators that set the USB and USB were present at the slide switch. However, the output from the slide switch had no output. I removed the slide switch and found that it to be open between the inputs to the output.

The tube for the carrier oscillator circuit is V11B 12AT7. The USB circuit is 2306.7 KHz and the LSB circuit is 2303.3 KHz. Both of these are set by quartz crystals.

Carrier Oscillator Slide Switch Assembly

Fortunately, I had bought several slide switches and replaced the faulty slide switch. I also concluded that the Tune/Bias slide switch on the front panel may also be suspect. That too was open and it was replaced. Slowly, the radio was coming alive.

I also replaced the crystals themselves. The crystals were supplied from the **Heathkit Users Group**

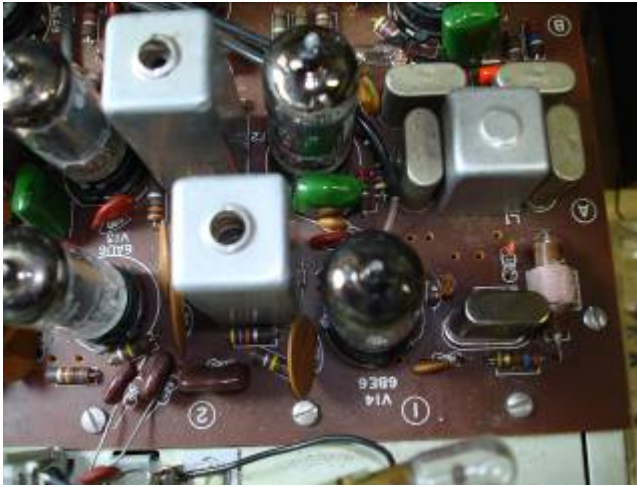
Figure 5

The next part of the investigation was to look at another signal that is generated in the radio. That was the heterodyne oscillator circuit. This circuit is used to mix with other signals to either receive the 7.2MHz to 7.3MHz or transmit the 7.2MHz to 7.3MHz Signal.

oscillator was dead. There was no output power from the transmitter part of the circuit.

My first thing was to remove all of the components. Most of them were at least 20% out of tolerance. I kind of expected it, for a 50 year old radio.

I removed the crystal and tested it in a test circuit that I fabricated. The crystal was dead.

Part Placement of the Heterodyne Oscillator

I tried the easy thing first and replaced the 6BE6 V14. That did not correct the problem.

I thought that I would go on line and get a crystal but quickly rejected that I idea. If I did I might wind out with a 50 year old crystal. I have found that other Heathkit radios, have had dead crystals. What I did was to buy a crystal from a commercial crystal company. The cost of the commercial crystal was the same as the cost of a crystal available on line.

In the HW22A the heterodyne oscillator crystal is 11.190MHz. When the new crystal was installed, the radio receiver came alive and tuned, the band listening to several clear LSB signals.
